TECHNICAL INSPECTION REPORT

NAGATO (Ex-Jap BB)

TEST ABLE

OPERATION CROSSROADS

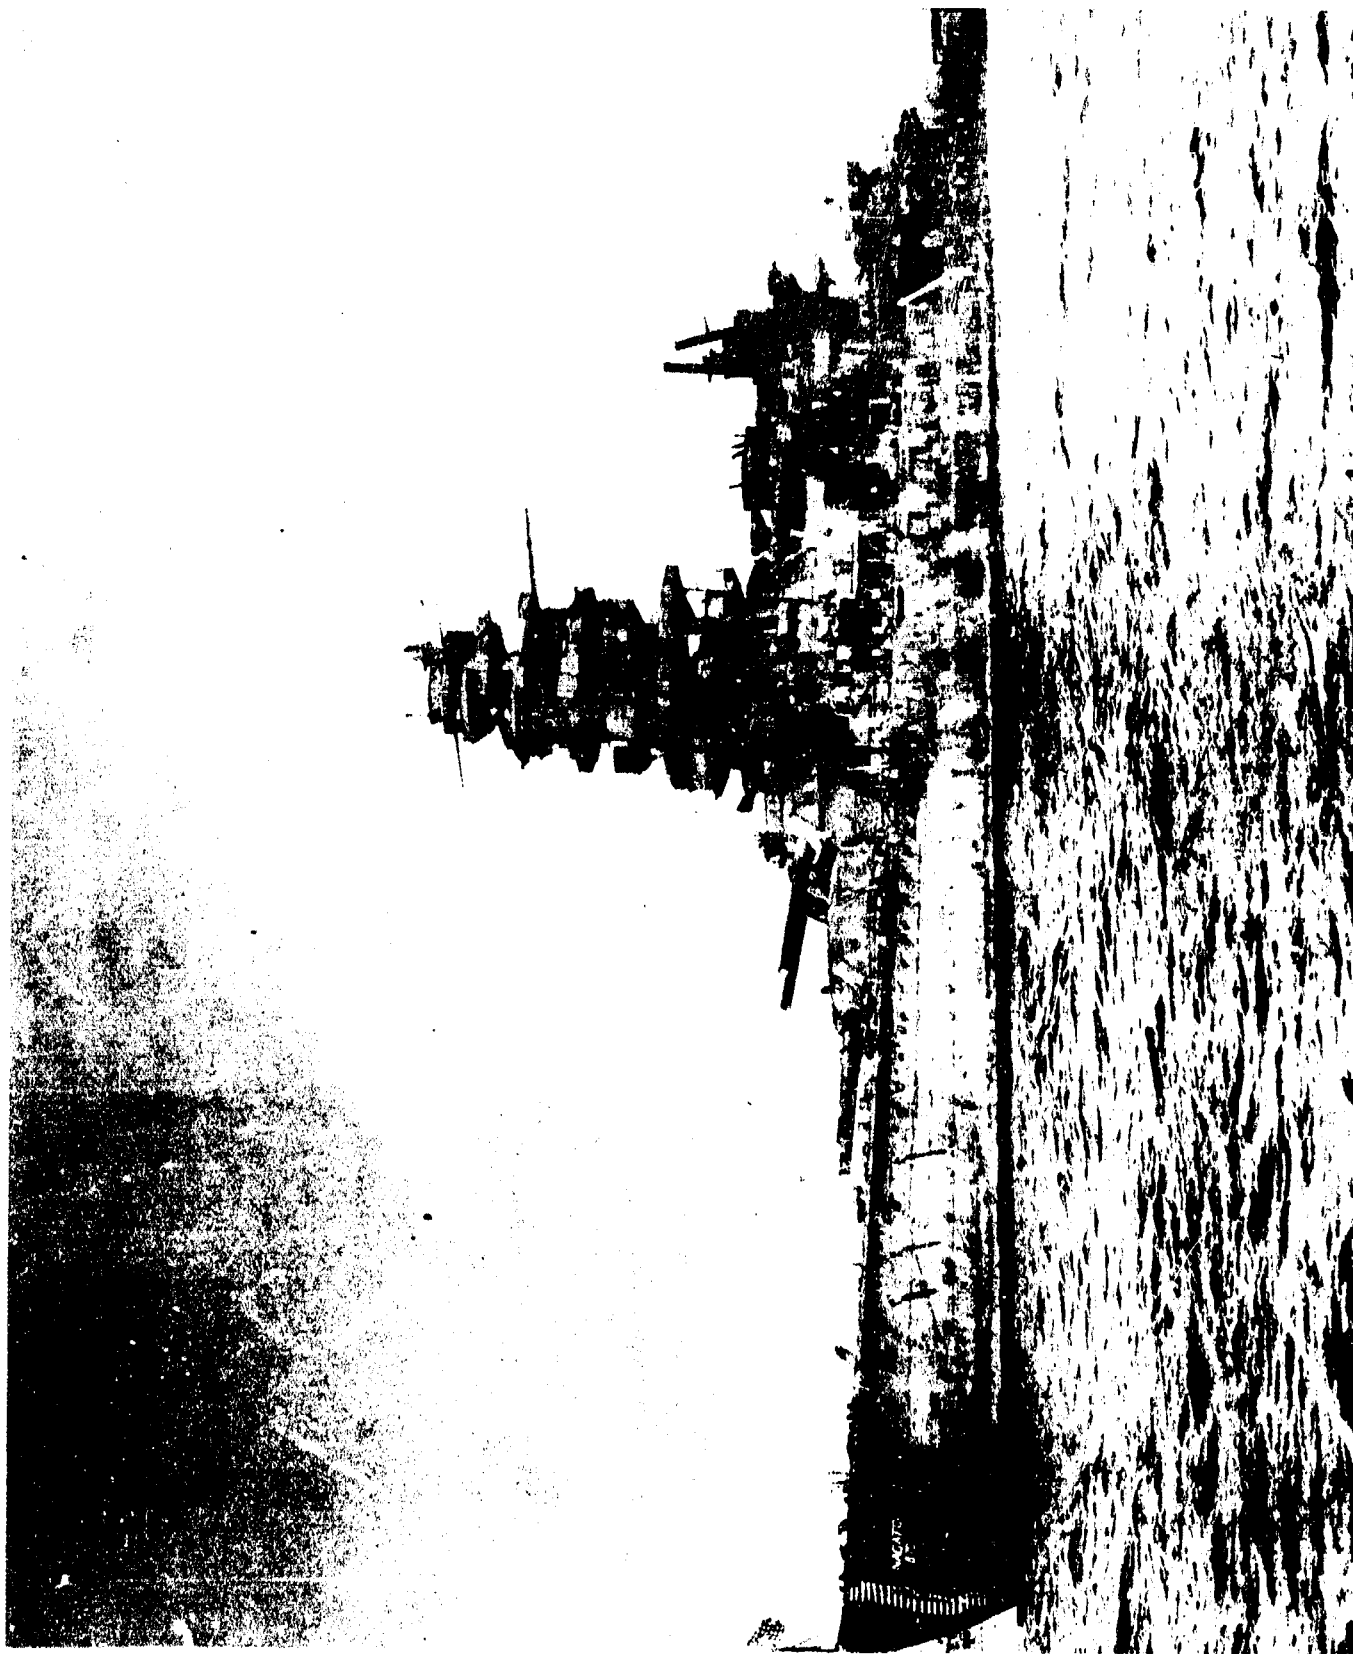
BB-CR-227-513-6. View from off port bow after Test A.

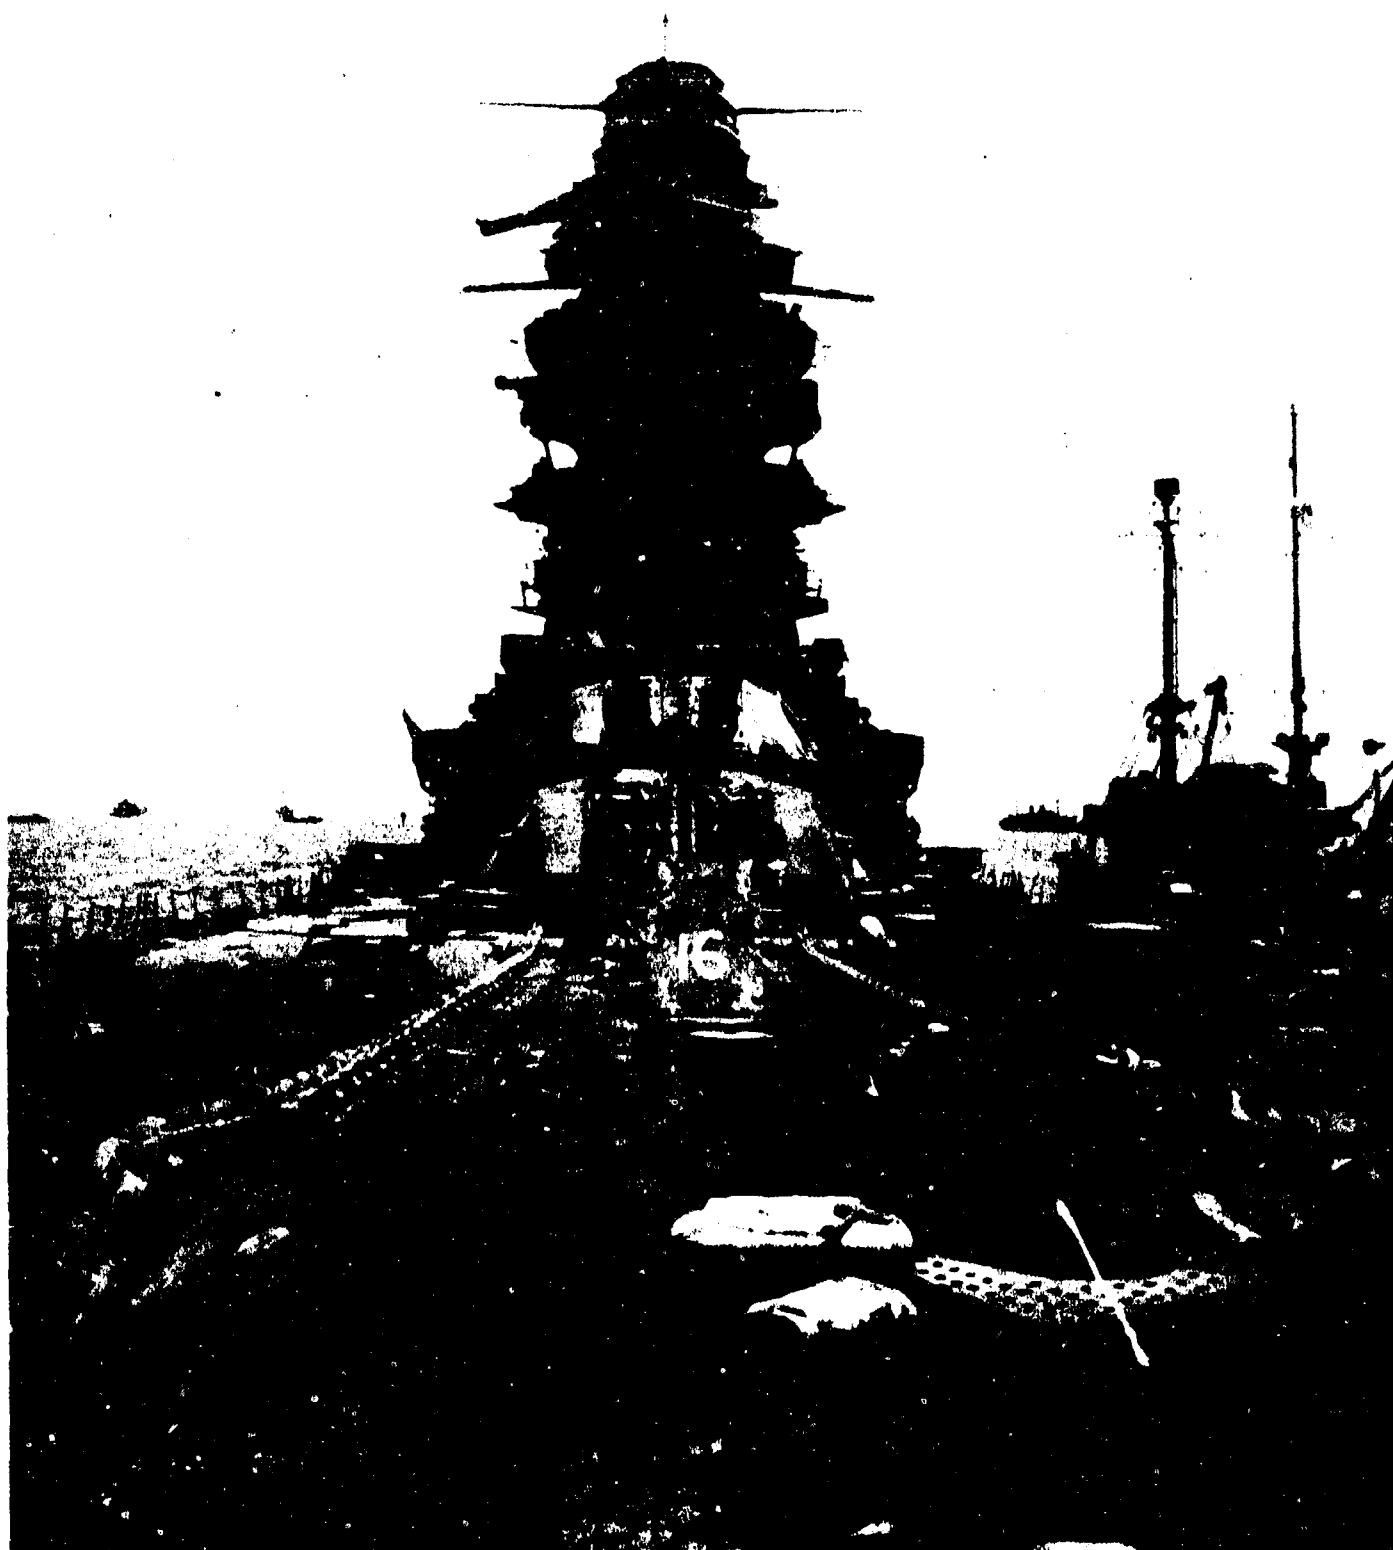
There is no change, due to the test, in the usability of the weather decks. (Photos 1763-10 and 1764-3, pages 72 and 73). The small fires in the wood deck covering generally covered an area of two or three square feet. A few exposed ladders were bent or had broken rungs. (Photo 1816-2, page 74).

AA-CR-68-1763-10. Looking aft from forecastle.

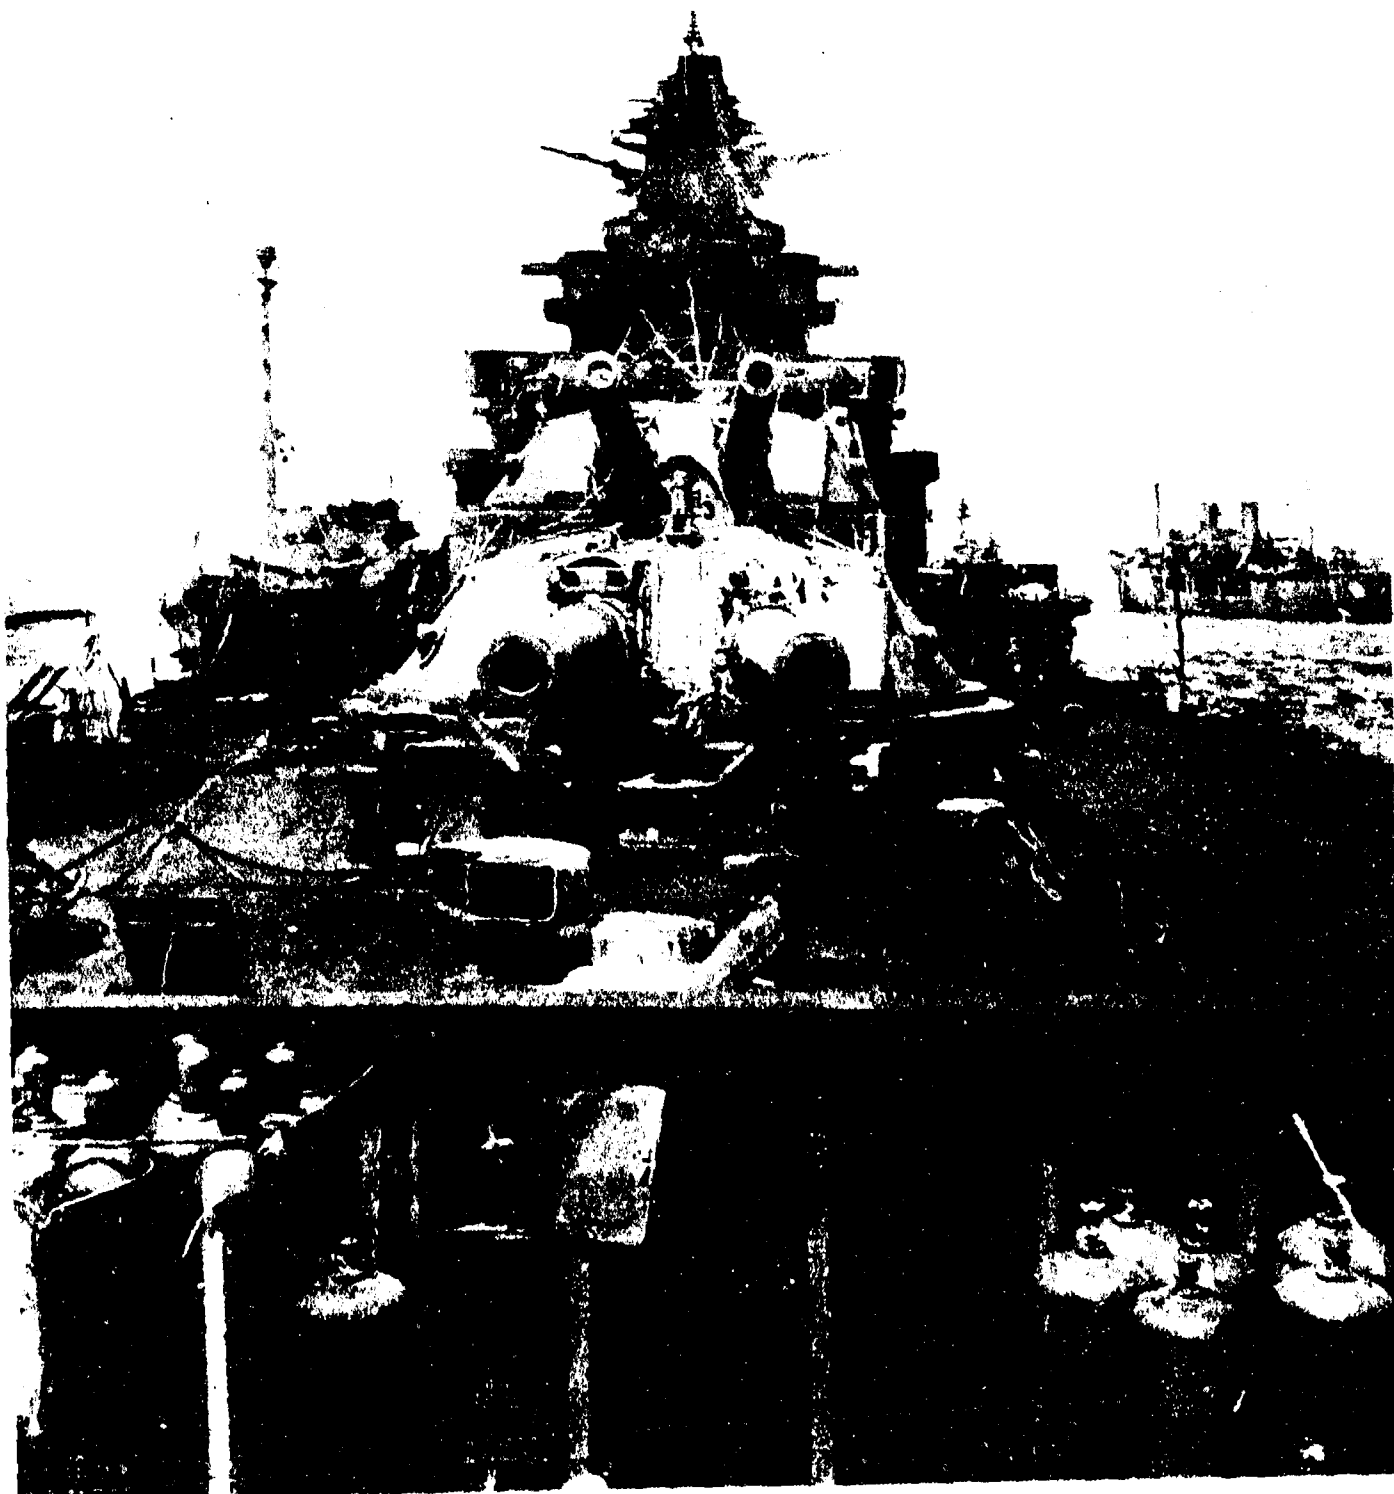
AA-CR-68-1764-3. Looking forward from stern. Note gas stowage has been rearranged.

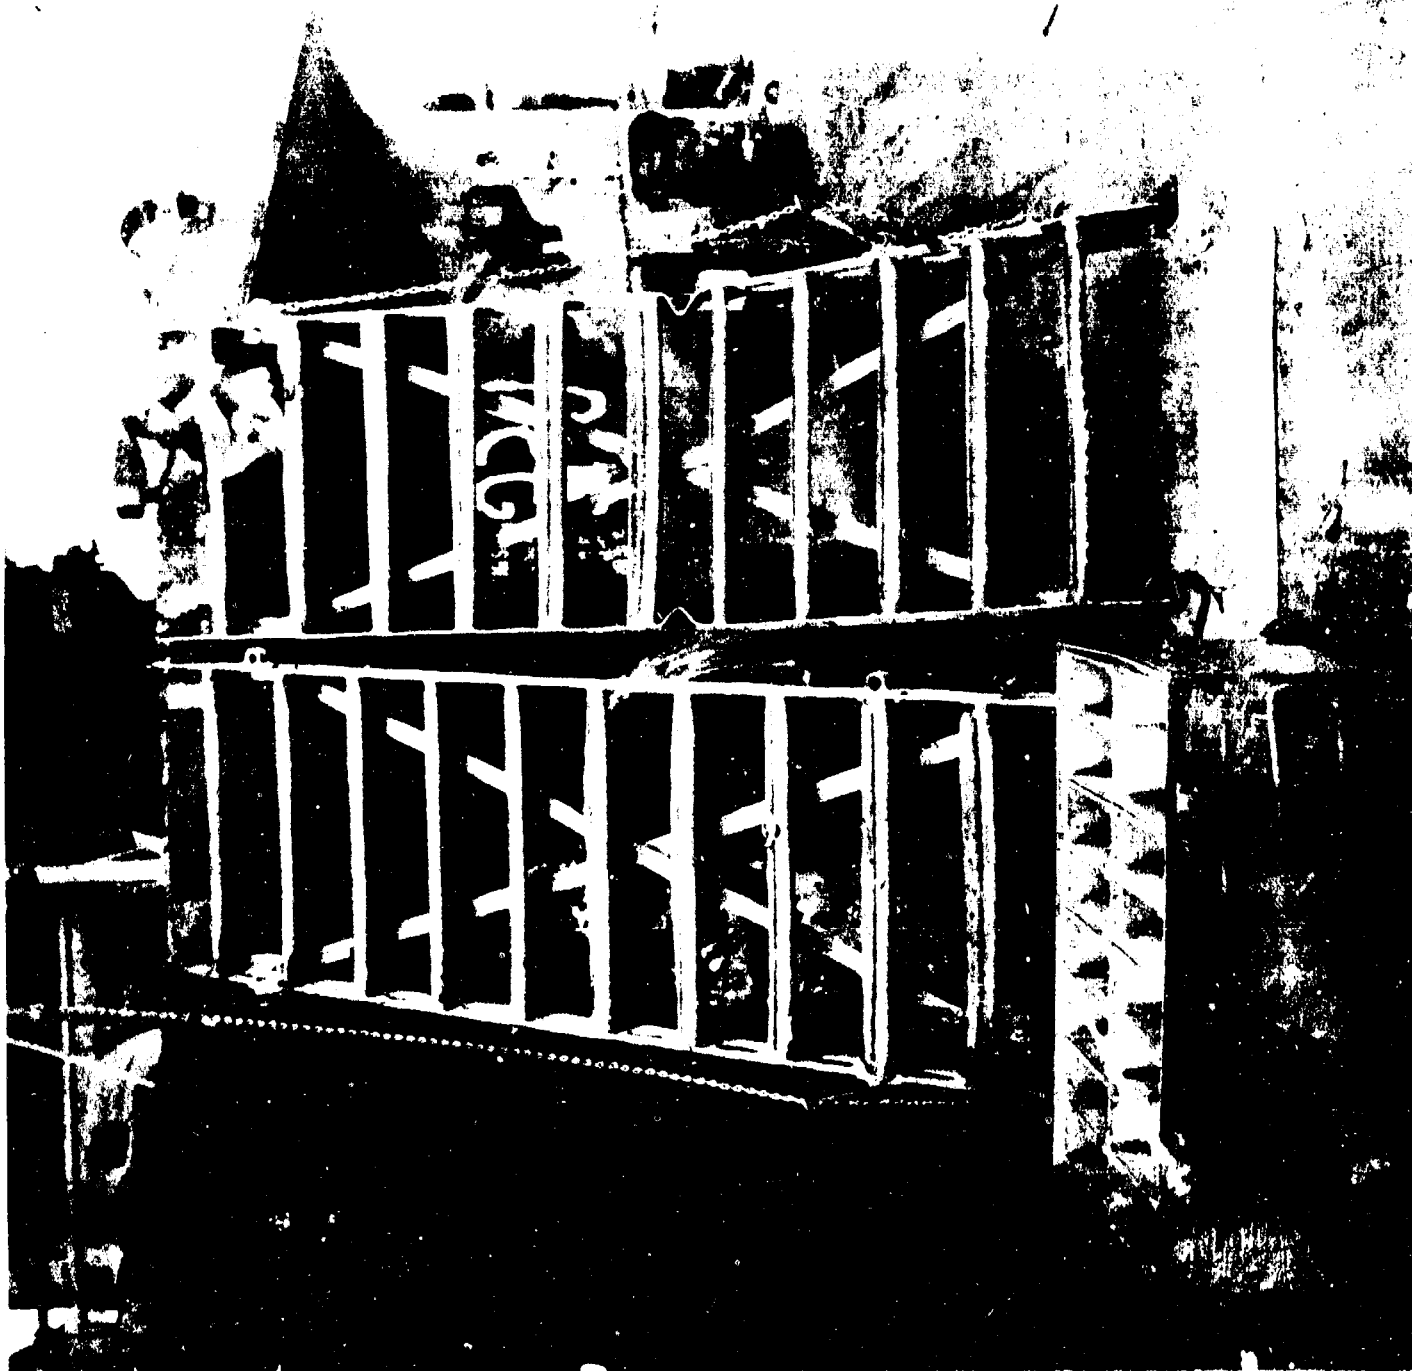
AA-CR-79-1816-2. Looking forward at buckled ladder, frame 235, main deck.

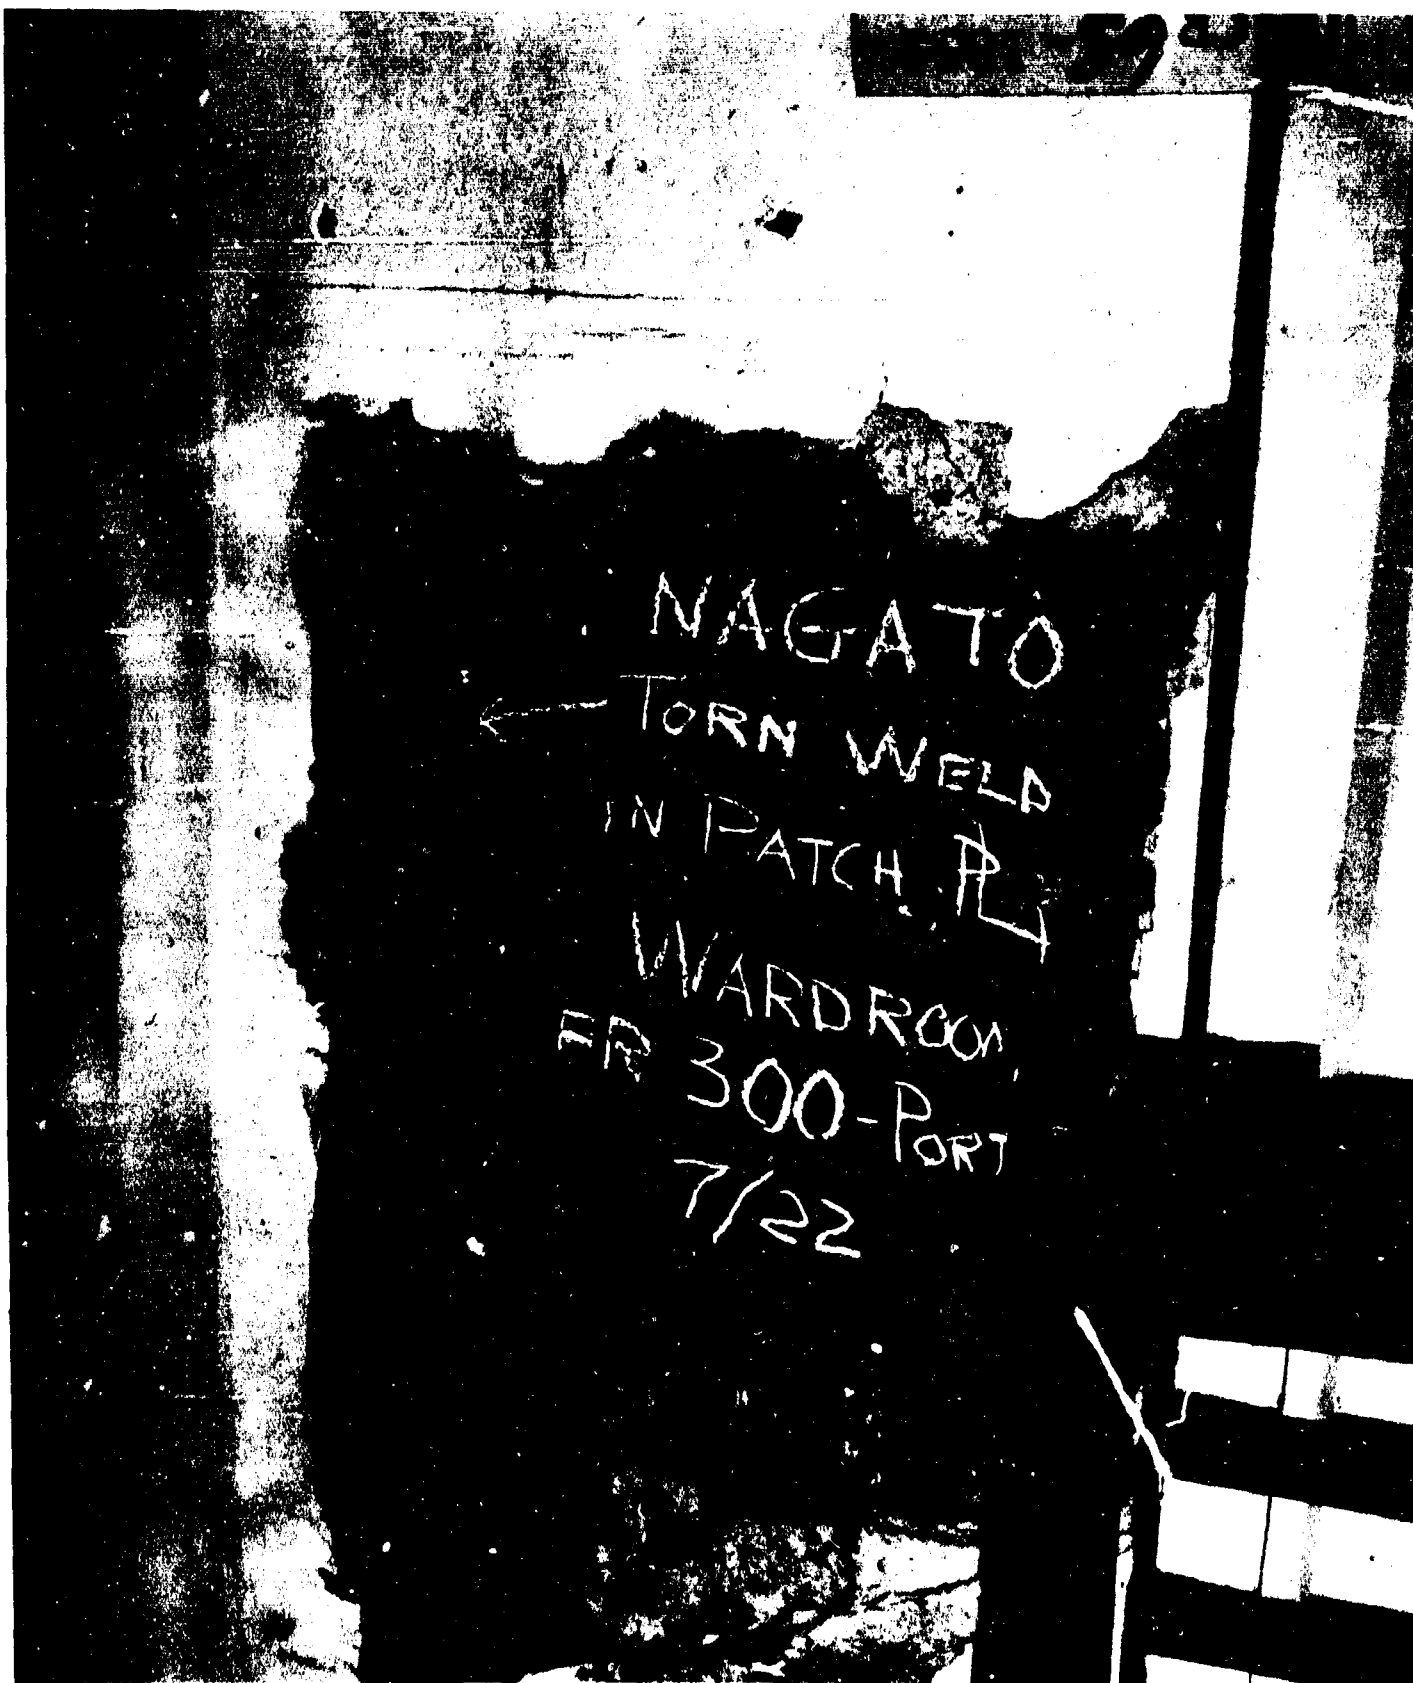
There is a cracked weld in way of a pre-test patch plate at frame 300, port side, about four feet above the second deck., (photo 1851-9, page 80 .)

AA-CR-65-1851-9. Looking outboard at frame 300, second deck, port side at cracked weld in way of patch plate.
